FLORIDA CRUSHED STONE
ENGINE TEAR-DOWN April 29, 1993

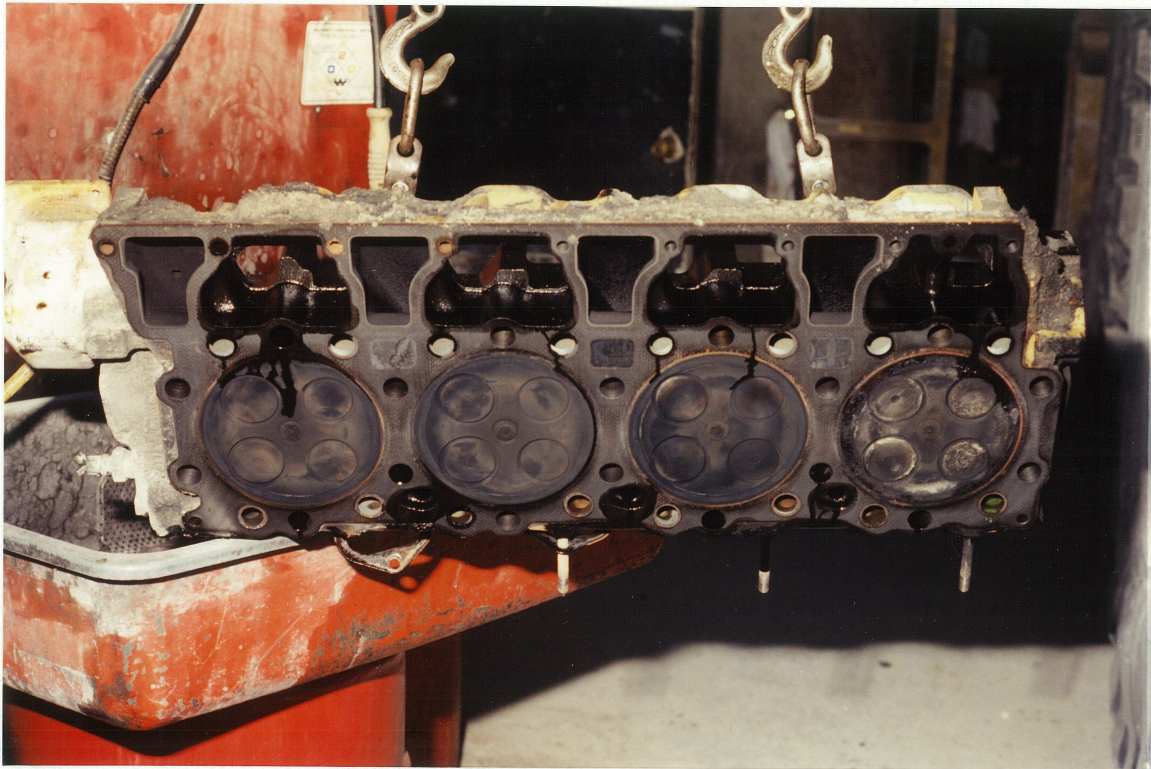
The following photographs are of a 3408 CAT V-8 with 13,788 hours. Please notice the absence of hard carbon deposits on the three combustion surfaces on the left side. The combustion surface on the extreme right was the reason for the engine failure - a broken piston ring.

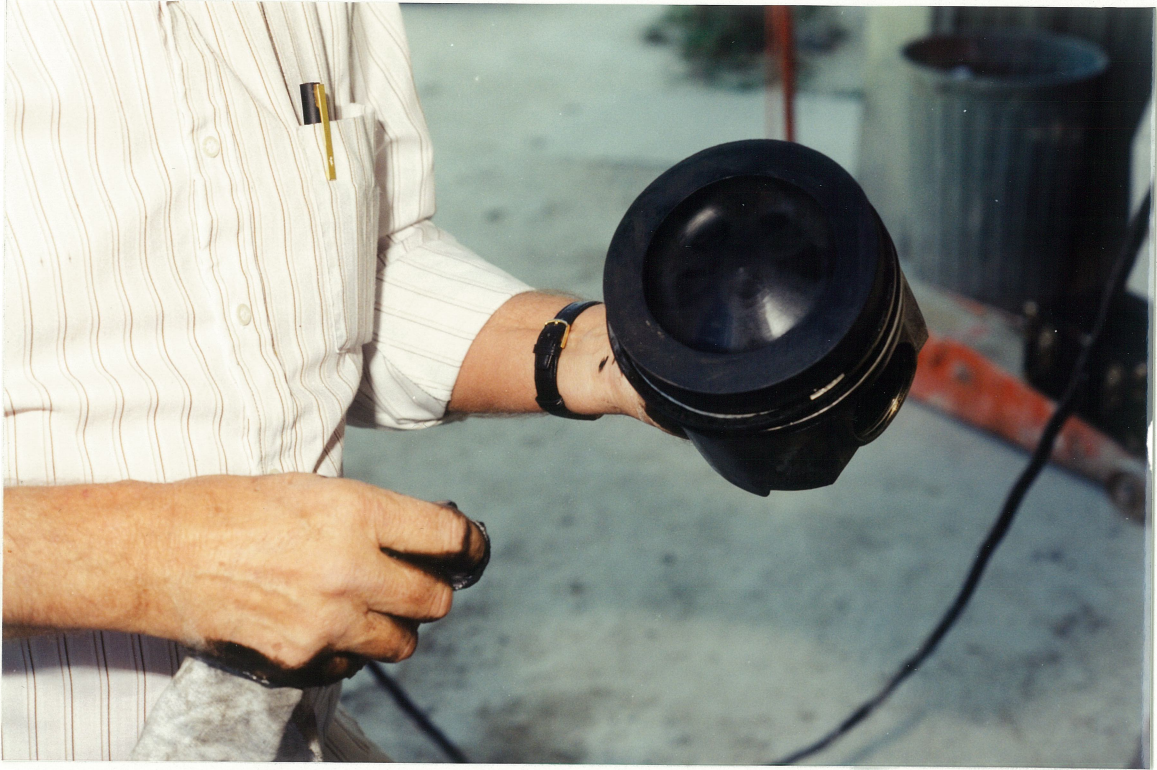
The photograph above is of a piston from the same 3408 Cat V-8. It too wiped clean with just a few passes with a shop cloth.

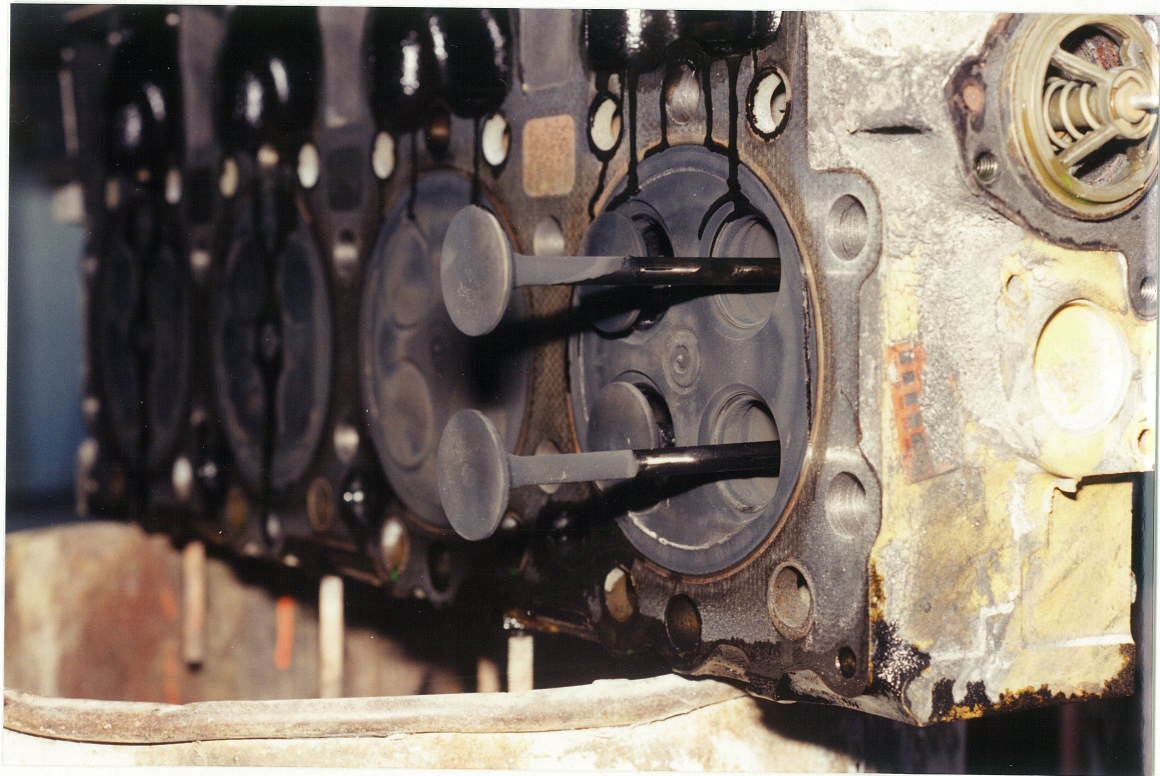
The photograph above is of the exhaust valves. There is also an absence of hard carbon on the stems.

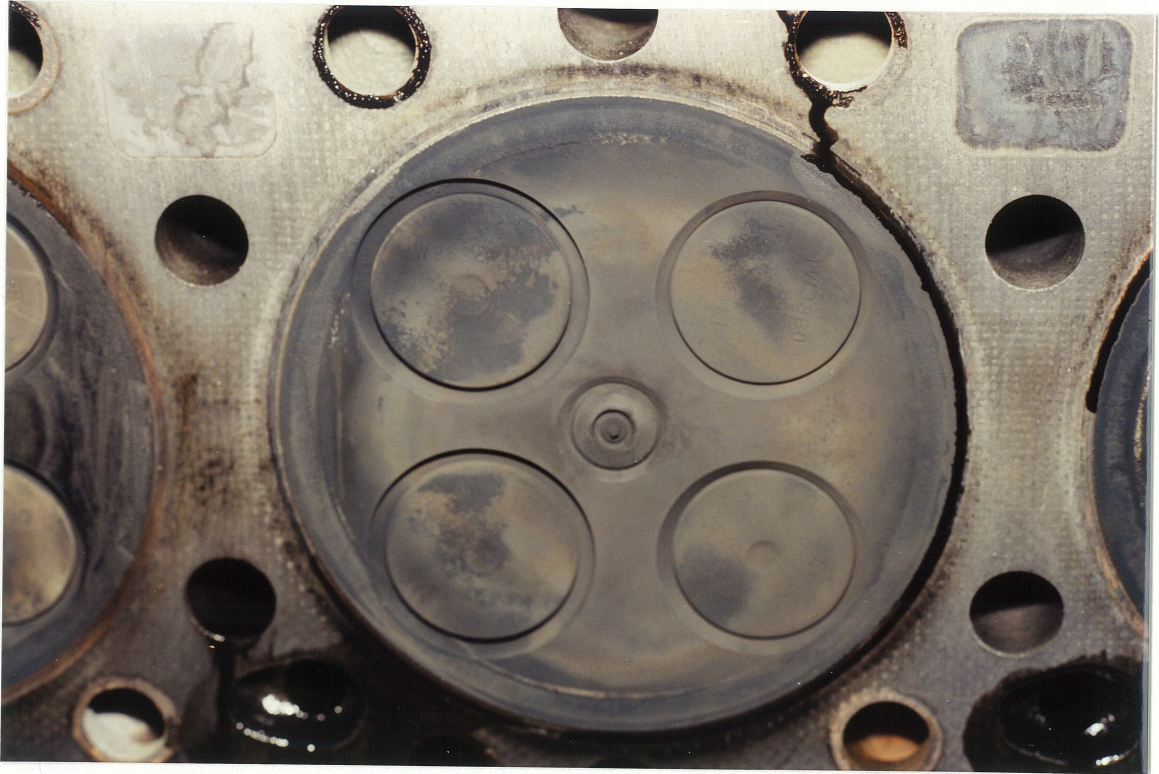
The photograph above is a close-up of one of the cylinder combustion surfaces as it appeared after removal.

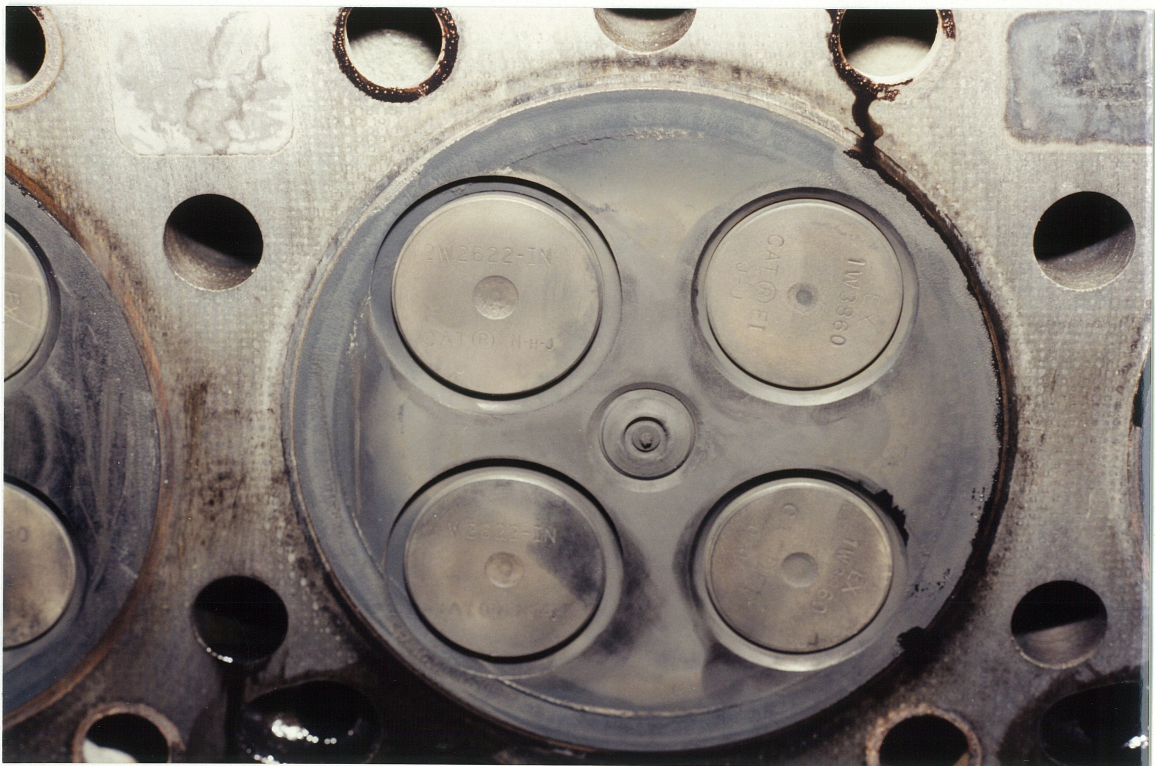
The photograph above is the same combustion surface. The valves were wiped with a shop cloth. As can be seen the part numbers are easily legible.
